Z. Plewako

STRENGTHENING OF THE REINFORCED CONCRETE TANK AFTER FAILURE

The paper describe an interesting case of rectangular reinforced concrete tank strengthening. Due to errors in reinforcement design, the long walls of the tank were seriously cracked and starts to leak during the water test. As alternative to total tank demolition, a simple and effective strengthening method was developed and applied. Because the basic defects occurred in long walls of structure, the tie system was designed and constructed. The group of precisely located bar ties anchored on the strengthened walls outer surfaces reduced the stresses in these walls to the level, which could be carried by structure with existing reinforcement. The ties and their anchorages were made of stainless steel, and during design special attention was paid to actual technical state of the tank structure and its environmental conditions. The successful strengthening allow the tank to start the operation with only small time delay and any problems actually noticed.

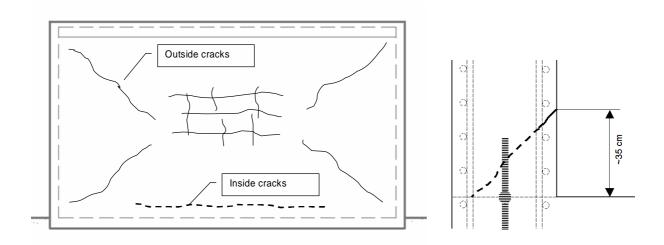
Fig. 3. Left: sketch of outside cracking. Right: probable progress of the inside crack

The test was immediately stopped and the tank was empted. The review of the structure shows characteristic crack pattern on both long side walls area. Additionally, there was a single horizontal crack noticed along the long walls located 30 cm above foundation raft.

The failure analysis. Observed cracking is typical for overload of the tank structure, particularly for the longside wall panels. The cracking distribution is characteristic for yield line mechanism of failure of slab supported on all edges [1].

According to typical behavior under increasing hydraulic inside pressure, the initial yielding started on bottom edges (inside, horizontal crack), and spread through the slab as moments were redistributed from yielded regions to areas that still remain elastic (panel span), yielding them at least (outside "envelope" cracking).

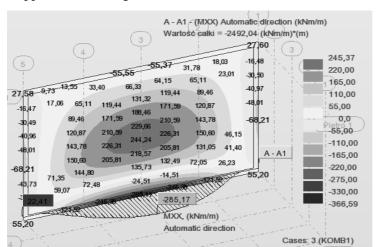
Fig. 4. Vertical ULS moments for long wall and bottom edge

The stresses in tank structure due to hydraulic pressure was obtained modeling the structure with FEM commercial software. The results for long walls are presented on Fig. 4 to 5 above.

Check calculations show, that for leak test conditions the stress in bottom edge vertical tensioned bars reach 536 MPa exceeding yield strength of steel (500 MPa). For other critical locations in the long walls, the service stresses were in the range between 250 and 330 MPa.

Checking the bending ultimate capacity of the wall structure, the obtained values for bottom edge was 80 % below required, and for span 54 % below.

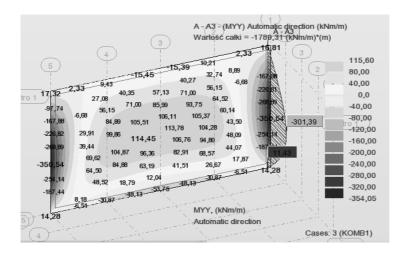
Fig. 5. Horizontal ULS moments for long wall and side edge

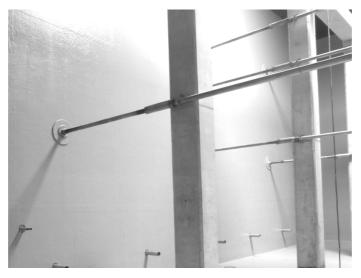
Fig. 6. Tie-bars installed and supported on the inner columns

Basic assumption for tying. The tie-bars run perpendicularly to the long walls planes, and passing through the drilled holes in walls are anchored outside. Because the sewage pressure acts identically to the opposite walls of the tank, so the ties give no unbalance effect on the walls, to which will be attached. For temporary support during installation and further tank maintenance operations, tie-bars were supported on the columns of the inner RC frame.

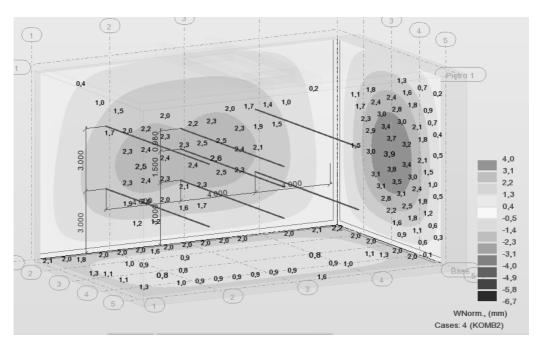
Fig. 7. Tie-bars location and tank walls deformations under service load

Tie number and tie group location was assumed considering the wall deformations due to inside pressure as well as available space limits of the inside tank process equipment, and accessibility to anchorage zones outside the tank. Then the location was optimized to minimize stresses and wall deformations obtained during FEM analysis.

The results of FEM analysis for final ties location are presented on Fig 7 and Fig. 8.

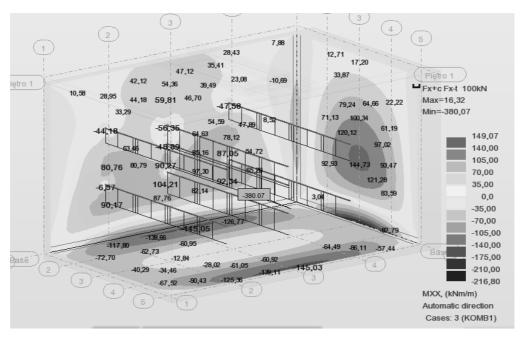
Fig. 8. ULS moments for walls and the maximum tension force in ties

Maximum ULS tension force $N_{Ed}=380.07\ kN$ (Figure 8) for tie-bar shank cross-section area $A_0=28.3\ cm^2$ results in stress:

$$s_{Ed} = \frac{N_{Ed}}{A_0} = \frac{380.07}{28.3} = 13.4 \text{ kN/cm}^2 = 134 \text{ MPa}$$

which is less than design yield strength [2]: $f_{yd} = \frac{f_y}{g_{M0}} = \frac{200}{1.1} = 182 \text{ MPa}$

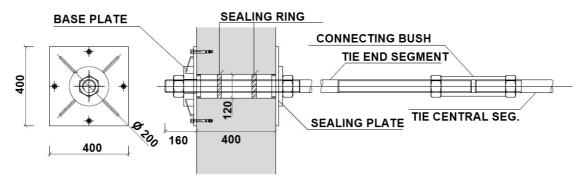
Fig. 9. Construction of tie-bar and it's anchorage

For those reasons the stainless steel round bars were used for ties, with relatively large diameter of 65 mm, and with no significant pretension.

Large diameter reduce the stress level and elongation due to tying force. It also improve tie resistance to corrosion, so any additional protection is required. The steel grade A316L (1.4404) was choose for specified environment aggression and appropriate strength ($f_v/f_u = 200/500$ MPa, in: [2], Tab. 2.1).

base plates. Due to space limits out and inside the tank, the tie bar was divided into two short end segments and inner longer one (see Fig. 9). The tie segments connections and end anchorage was made as threaded – for length adjusting and omitting welds as more sensitive to corrosion.

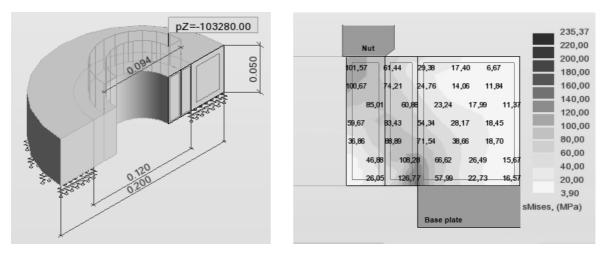
The base plate dimensions results in press to concrete with net stress 4.7 MPa. The stress in anchoring block Ø200 mm is presented on Fig. 9.

The maximum stresses calculated based on Huber-Mises's theory equal to 235.37 MPa locally exceed yield stress of steel equal 200 MPa, but found to be within safe limits referred to ultimate strength of 500 MPa.

Fig. 9. Stresses in anchoring block
