EVALUATION OF FIRE IMPACTED RAISED SLABS OF RESIDENTIAL BUILDING IN LVIV AND THEIR REINFORCEMENT

The research and analysis of technical conditions, deflections, and bearing capacity of subjected to fire impact reinforced concrete slabs of raised “panel per room” typical design model 1-480a of a five-storey residential building in Lviv are present.

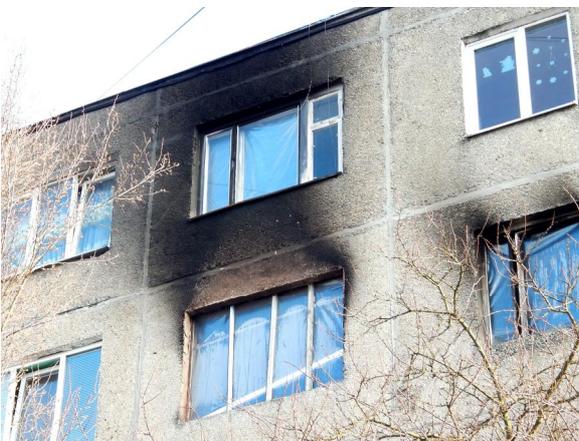
Fig. 3. The window of the first room of apartment No. 160 on the fourth floor where the fire started

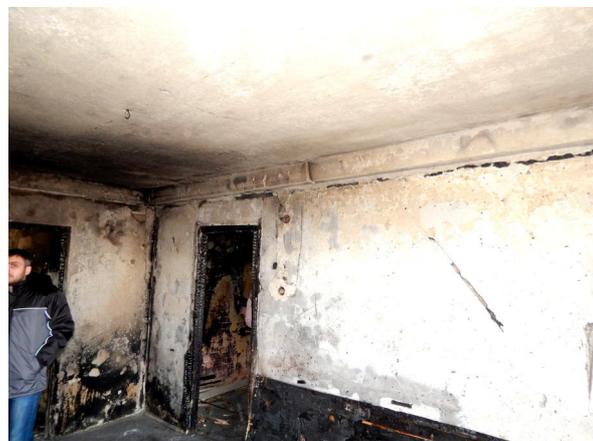
Fig. 4. The condition of the first room in the fire zone. View from the outer wall of the main facade of the building

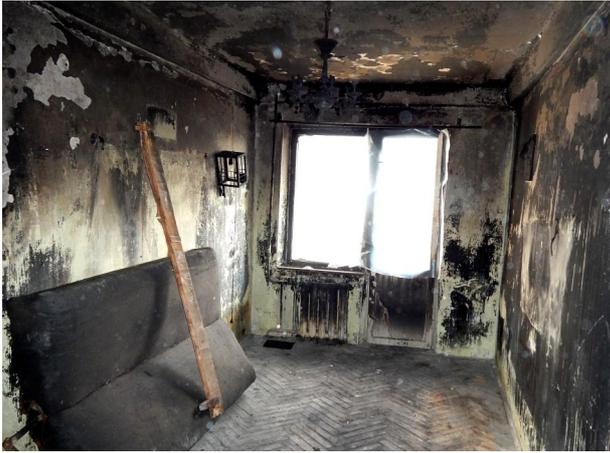
Fig. 5. The condition of the second room in the fire zone.
View from the inner wall

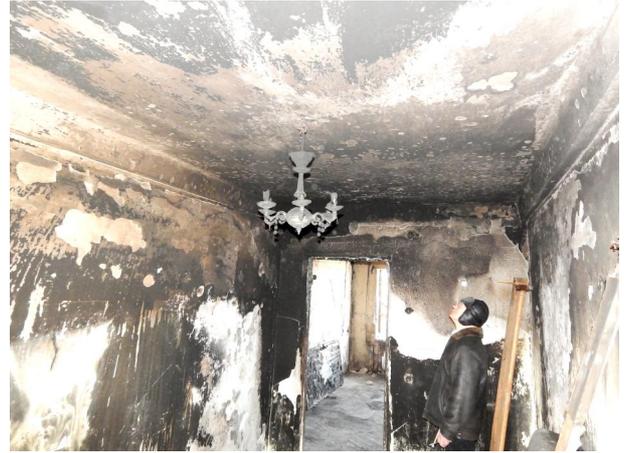
Fig. 6. The condition of the second room in the fire zone.
View from the outer wall

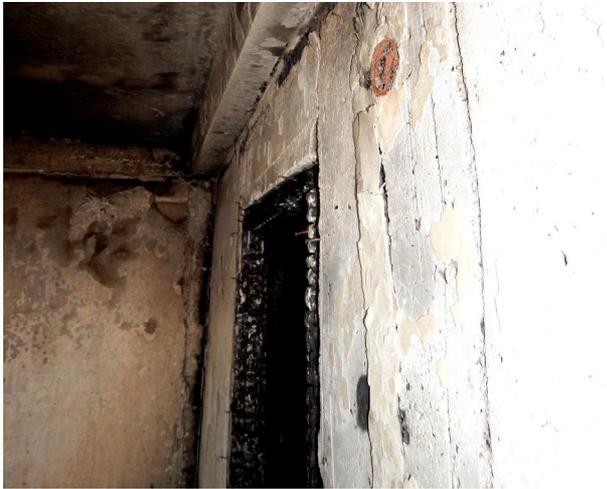
Fig. 7. The condition of the door frame in the partition,
which was located in the fire zone

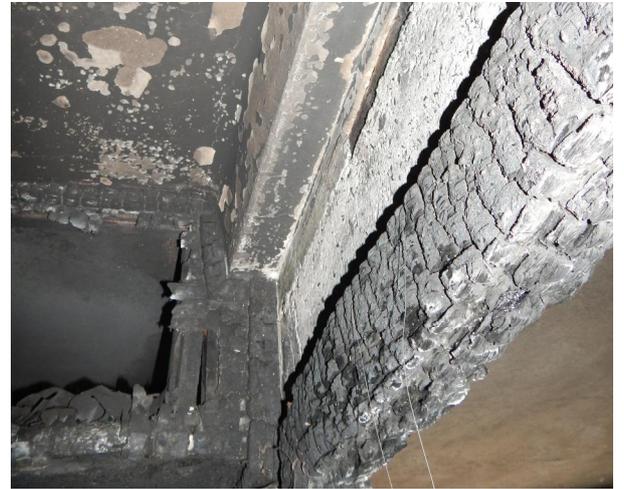
Fig. 8. State of constructions of the kitchen and sanitary
block in the fire zone

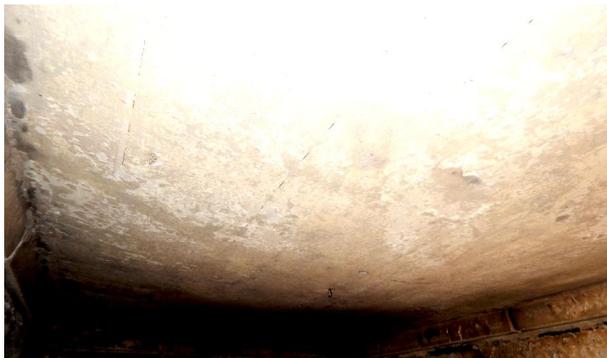
Fig. 9. View of the central part of the flange of the raised
panel of the floor slab above the first room. Deflection
($f=70$ mm) of the flange with the formation of two cracks
in it with an opening width of 2–3 mm, located in the
middle of the longitudinal and transverse spans

A significant decrease in the rigidity of the flange of the raised floor slab (which was only subjected to a constant load) in the fire zone above the first room (Figs. 9, 10) recorded during the visual inspection led to the determination of the actual deflection of this slab.

The measured deflection of the flange is $f=77$ mm with the formation of a significant number of cracks of small width and two cracks with a maximum opening width of 2–3 mm, which are located in the middle of the longitudinal and transverse spans.

Significant cracking is associated with the effect of high-temperature heat flow, in which, with a 10 mm thickness of the cover layer, the stress in the reinforcing wire mesh with a wire diameter of 3 mm went into the plastic stage. The steel wire mesh was significantly elongated, which was manifested by the maximum deflection of the shelf of the raised plate.

The resulting actual deflection f for the span $L_0=3180-150 \times 2=2880$ mm exceeds the limit $f_u=L_0/150=2880/150=19.2$ mm by $77/19.2=4.01$ times according to the standard (Systema zabezpechennia nadiinosti ta bezpeky budivelnnykh ob'ektiv. Prohyny ta peremishchennia, DSTU, 2006).

- the category of technical condition of the flange plates above the first room was assigned to the 4th category – emergency.
- the category of technical condition of the longitudinal ribs of the floor slab above the first room of the apartment was assigned to the 2nd – satisfactory.
- the category of the technical condition of the flange and longitudinal ribs of the raised floor slab above the second room was classified as 2nd – satisfactory.

According to the technical condition, the raised slab of the floor above the first room was to be strengthened, and the floor structure above this slab was to be levelled (Fig. 10). Complete replacement of the defective flange plate will lead to greater costs and inconvenience for the residents of the apartment on the next floor, which is located directly above the fire zone.

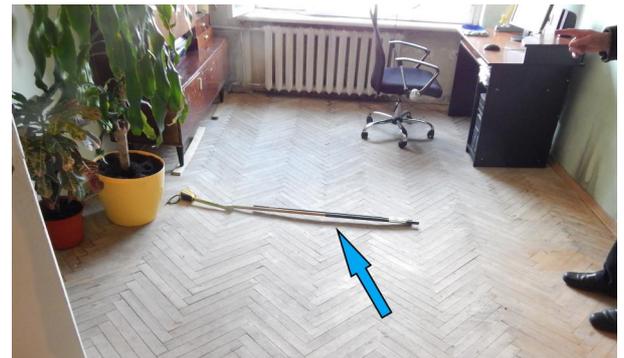
Fig. 10. View of the floor in the room above
the fire zone. Deflection of the floor in the first room
above the fire zone

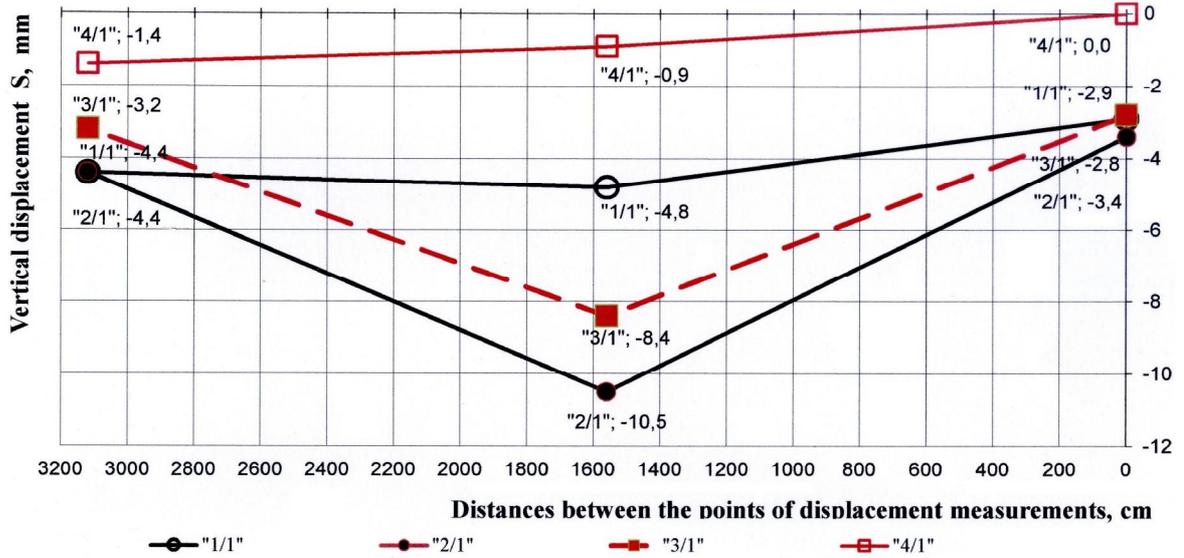
Fig. 11. Nonuniform excessive vertical deformations (sags) across the floor slab panel above the first room + installation inaccuracy (the support of the slab on the middle wall is 3 cm lower than on the outer wall)

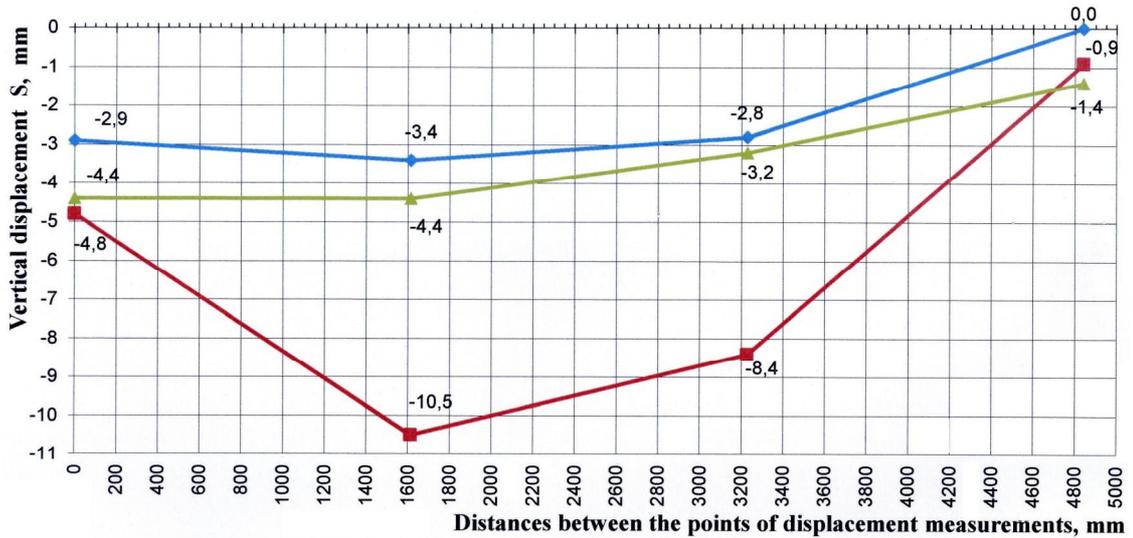
Longitudinal ribs plates have actual deflections $f=18.3$ mm and $f=17.3$ mm, which do not exceed the limit value $f_u=L/200=4670/200=23.75$ mm according to the code (Systema zabezpechennia nadiinosti ta bezpeky budivelnnykh ob'ektiv. Prohyny ta peremishchennia, DSTU, 2006). In the survey area, damages were detected in the raised panel slabs above the first and second rooms, which were associated with the effect of elevated temperature, which in various ways reduced their design load-bearing capacity and stiffness. Due to the intensity of the high temperatures in the first room, defects and damage occur in the shelf of the raised slab of the floor, which reduces the durability of the shelf of the raised slab due to the broken bond between the reinforcement and concrete.

Fig. 12. Nonuniform excessive vertical deformations (sags) along the floor slab panel above the first room + installation inaccuracy (the support of the slab on the middle wall is 3 cm lower than on the outer wall)

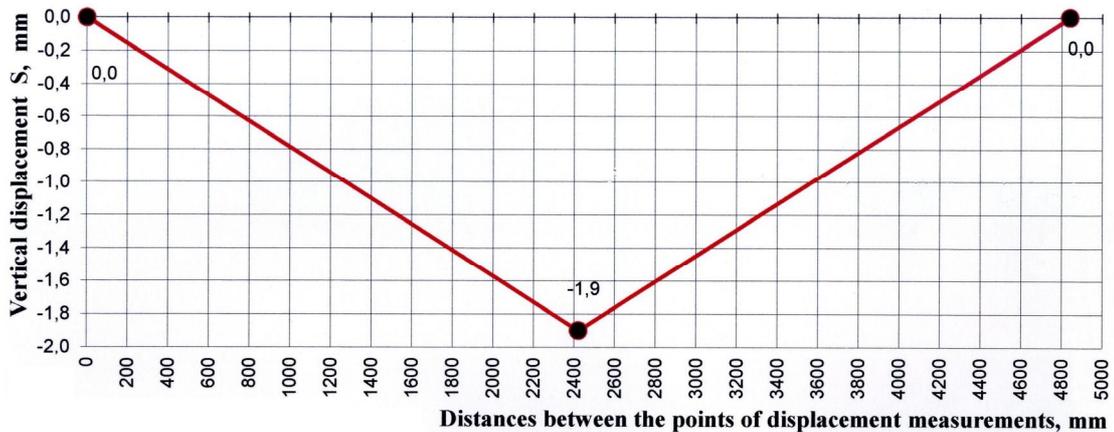
Fig. 13. Nonuniform excessive vertical deformations (sags) along the floor slab panel above the second room

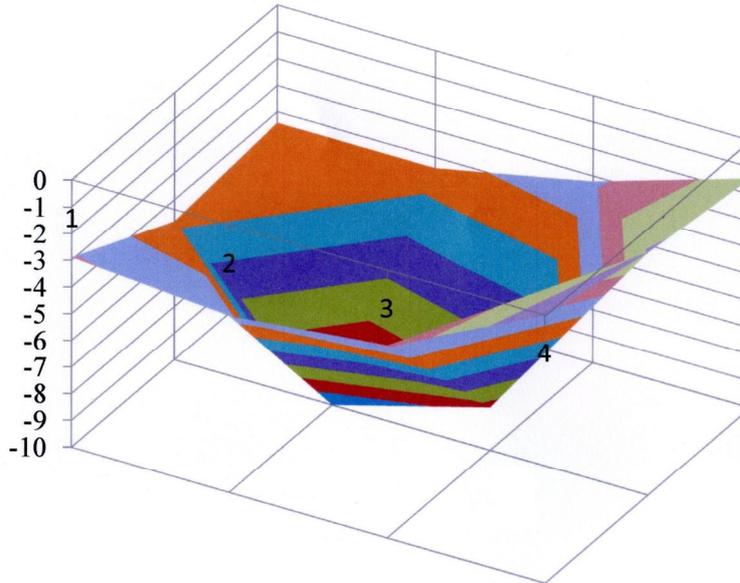
Fig. 14. Surface of the factual displacements (effect of high-temperature + effect of installation inaccuracy) of the floor panel slab in the first room
