## THE THEORY AND HISTORY OF ARCHITECTURE

**Mykola Bevz**

### THE DISCOVERY OF PAINTING DECORATIONS ON THE OUTSIDE WALLS OF THE CASTLES IN POMORIANY AND IN YAZLIVETS

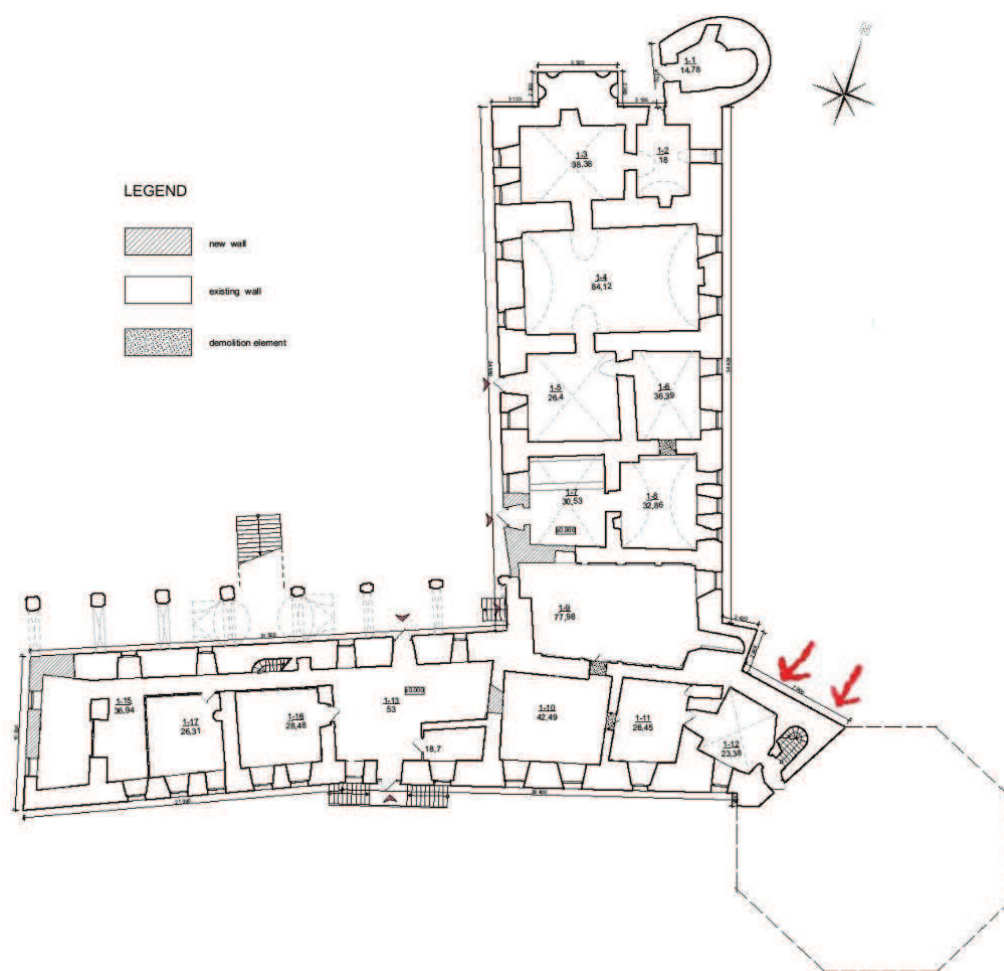
**Fig. 1.** Plan of the castle in Pomoryany as of 2017. Drawing – by Kalyna Havryliv .  
The arrow indicates the location of the painted wall.

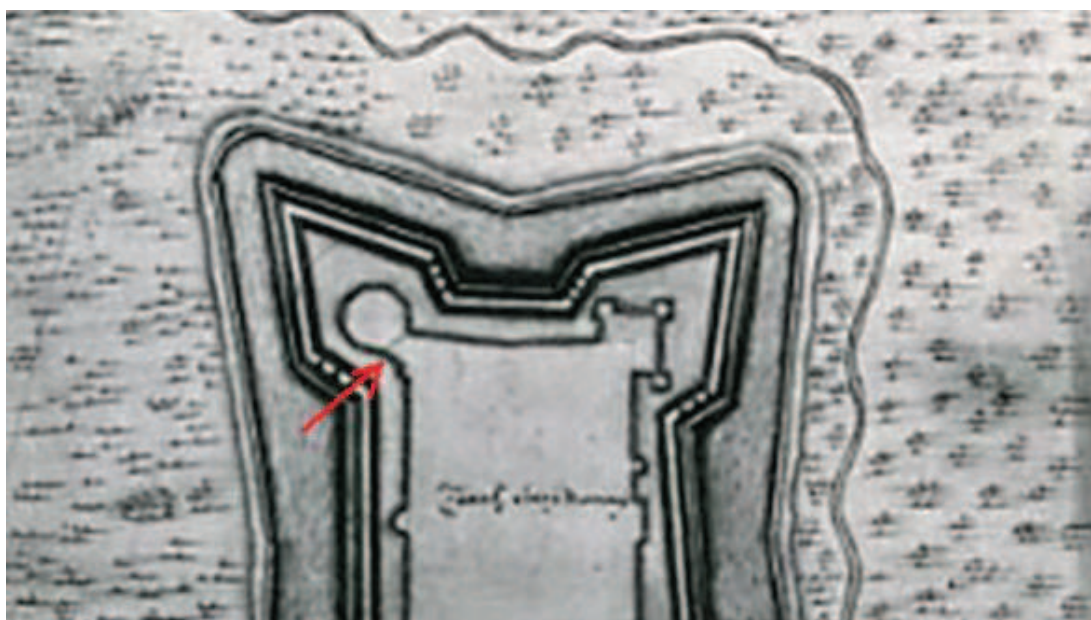
**Fig. 2.** Drawings of the fortifications of the Pomoryany castle taken from the work of Alexander Cholovsky.  
In the northeast corner, a round tower with facets is marked. The western wall we are exploring is a preserved part of the “neck” to this tower. This wall is marked by an arrow.

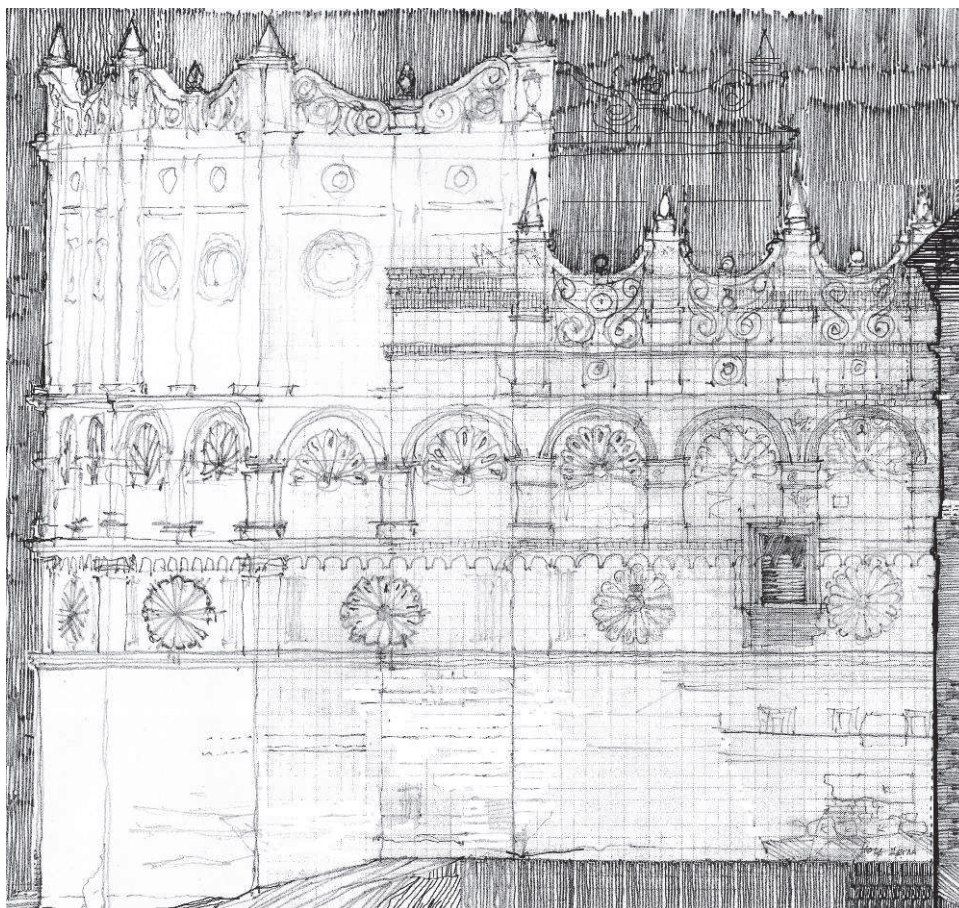
*Fig. 3. Hypothetical reconstruction of the lost octagonal Renaissance castle tower with polychrome pattern. Drawing by M.Bevz, 2017.*

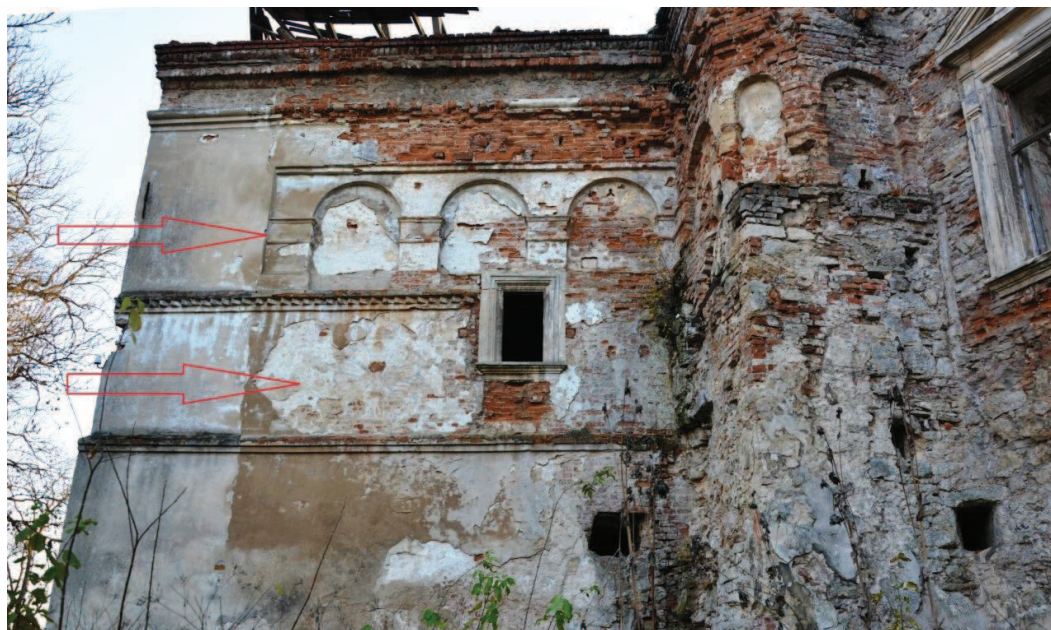
**Fig. 4.** The north wall of the corner tower of the Pomoryany castle.  
The places where the polychrome paintings preserved are indicated with arrows.

In the winter of 2018, due to unfortunate restoration work, the entire southern wing of the palace and the southern wall of the northern part collapsed. The western wall of the northeast tower we are exploring is completely ruined but has not yet collapsed. The photo fixation of the paintings we did September 2019 shows the slow degradation of the paintings due to the rains washing and the disappearance of the outer layer of the plaster that protected them.

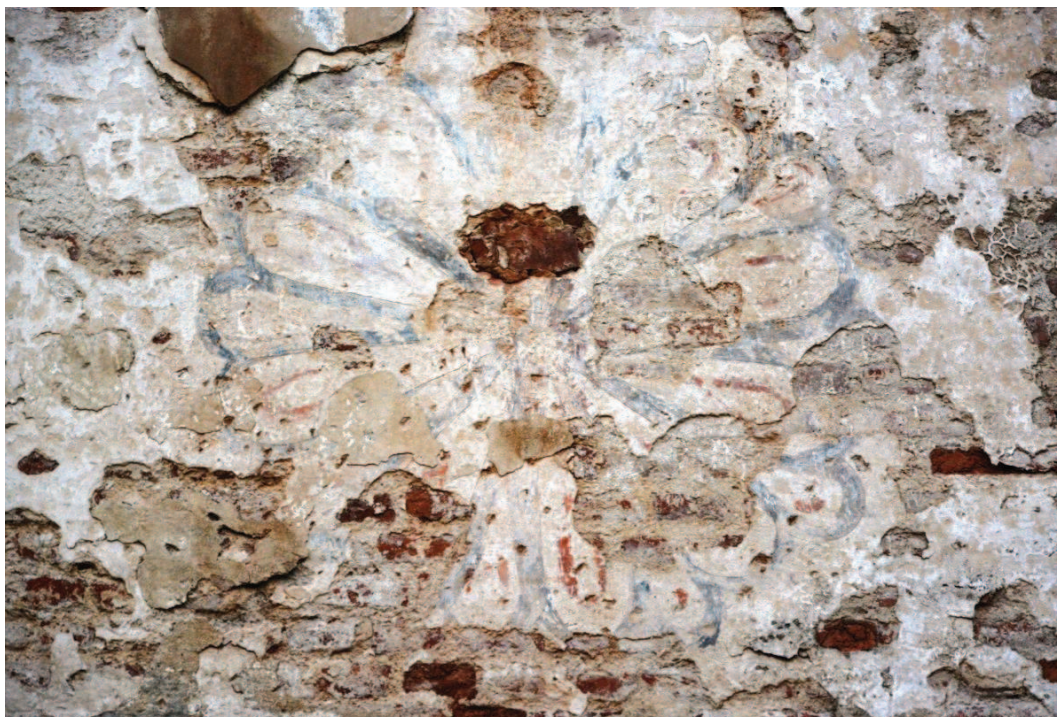
Red, grey and blue colours dominate in the paintings. The murals are in the state of an emergency. Most of them are lost, although preserved fragments can be used to reconstruct an integral image. The second tier of the tower was painted with rosettes almost two meters in size (Fig. 2), among which were drawn some geometric figures (Fig. 3).

*Fig. 5. A large rosette drawn on the 2nd tier of the outer wall of the corner tower of the Pomoryany castle.*

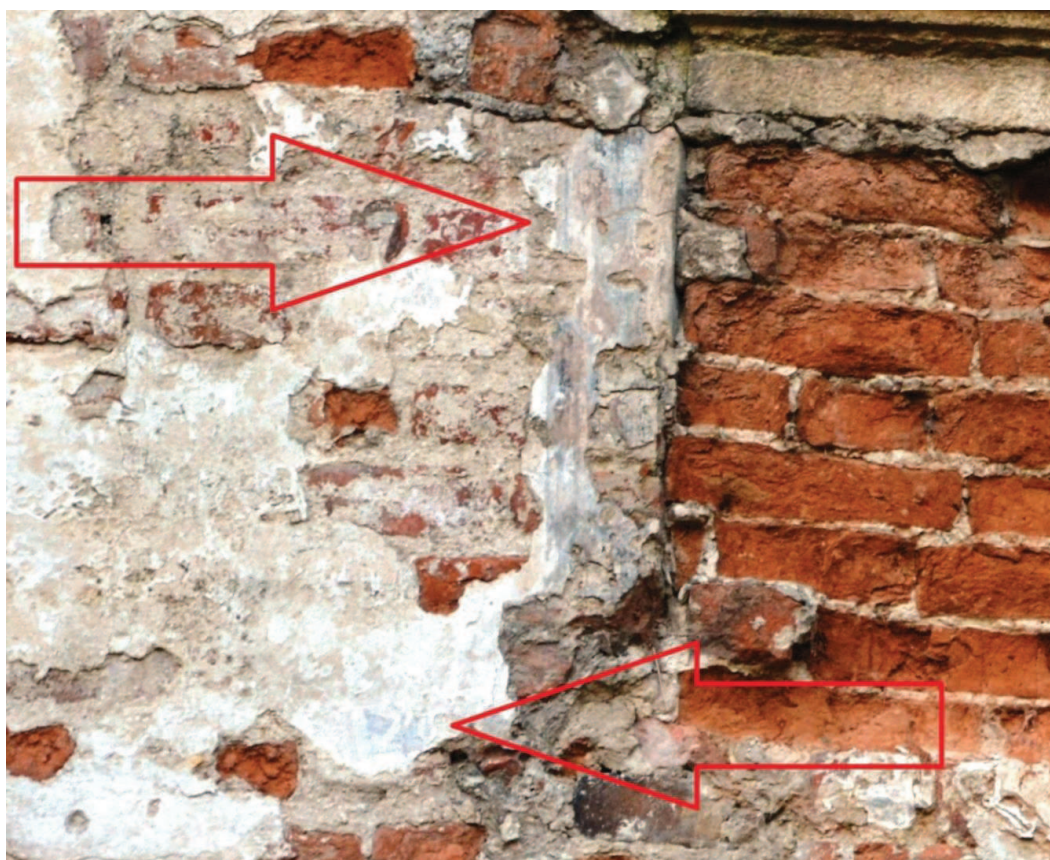
*Fig. 6. Vertical hand-drawn painting (arrow 1) near the old bricked-up window opening on the 2nd tier of the outer wall of the Pomoryany castle corner tower. On the left side to the painting remained very small fragments of some other painting (arrow 2).*

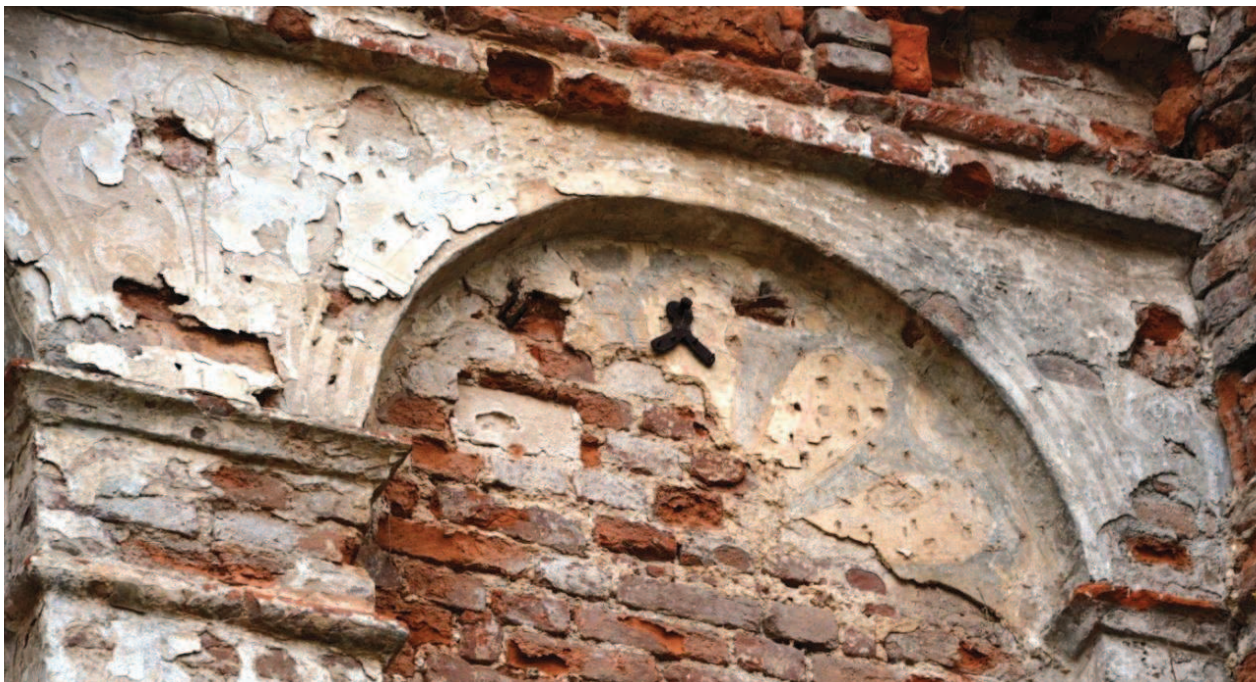
The third tier of the tower, which was built with a blind arcade, was also decorated with polychrome paintings. Their pattern corresponded to the arcade profiling of the wall. Under the arches were painted half-rosettes similar in style to those found on the 2<sup>nd</sup> tier (Fig. 4). The pilasters had hand-drawn fluting. Their traces are still barely readable. Above the arches, striped archivolts (at 7 belts) were drawn in detail. The triangular fields between arches above the pilasters are the most interesting: there is a large rose with symmetric branches. 30

*Fig. 7. Hand-drawn archivolts and half-rosettes in the arch belt on the 3rd tier of the outer wall of the tower. On the left side to the arch are fragments of a rose with branches*

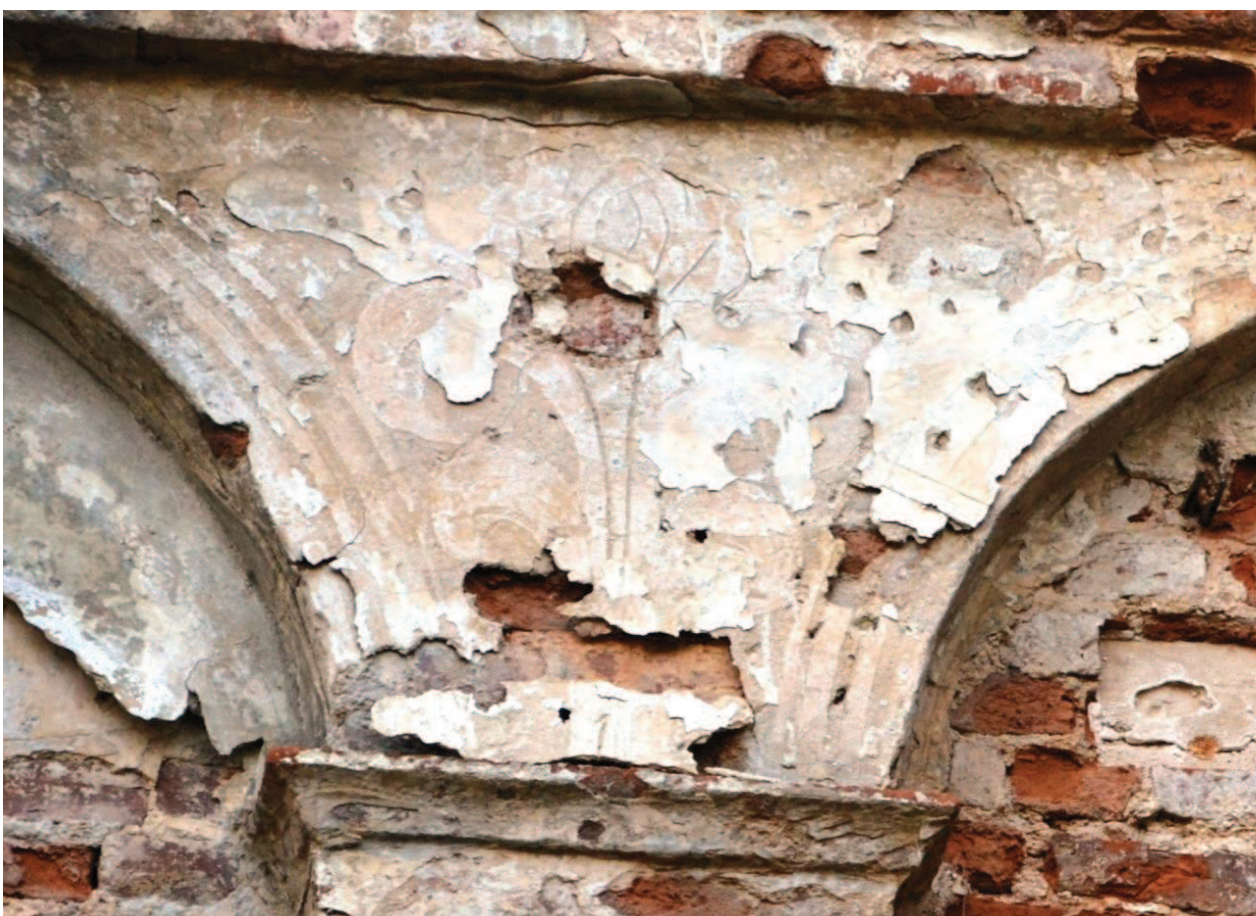
*Fig. 8. Hand-drawn rose with branches on the 3rd tier of the outer wall of the tower*

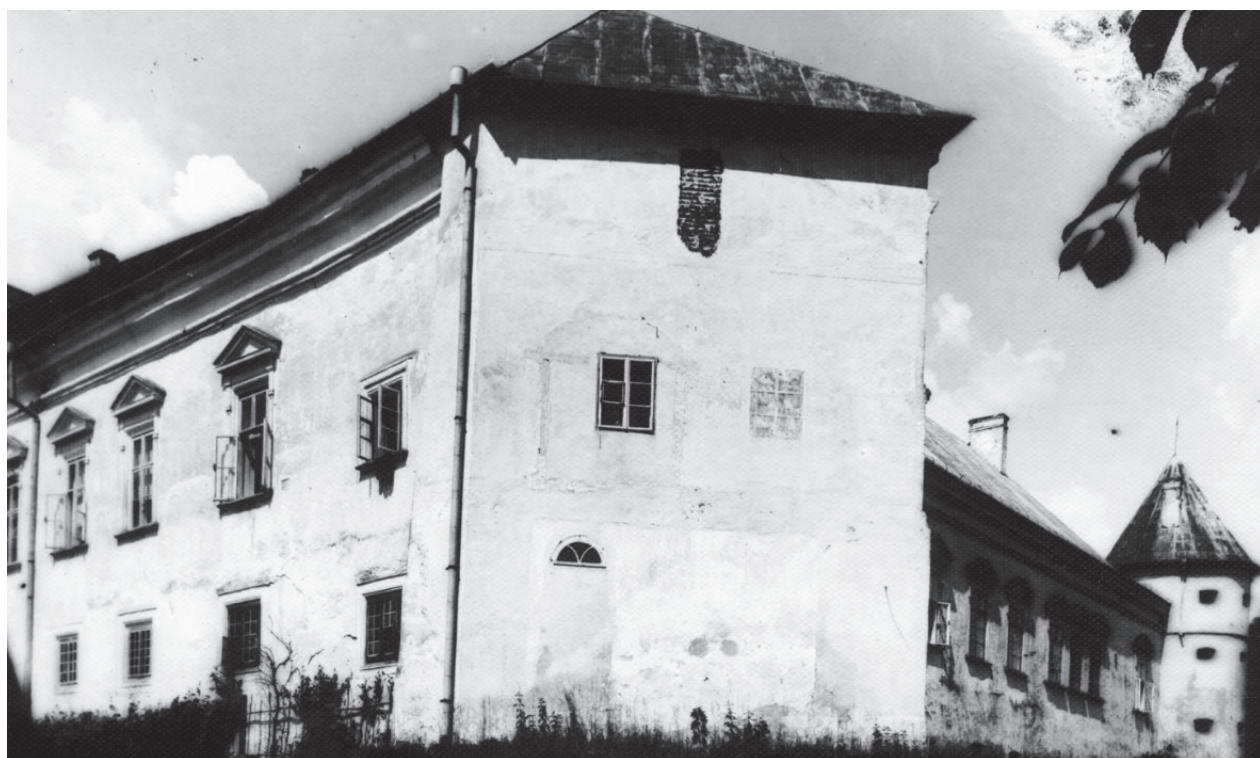
**Fig. 9.** The castle in Pomoryany. Photo from 1914. The place of the lost octagonal tower.

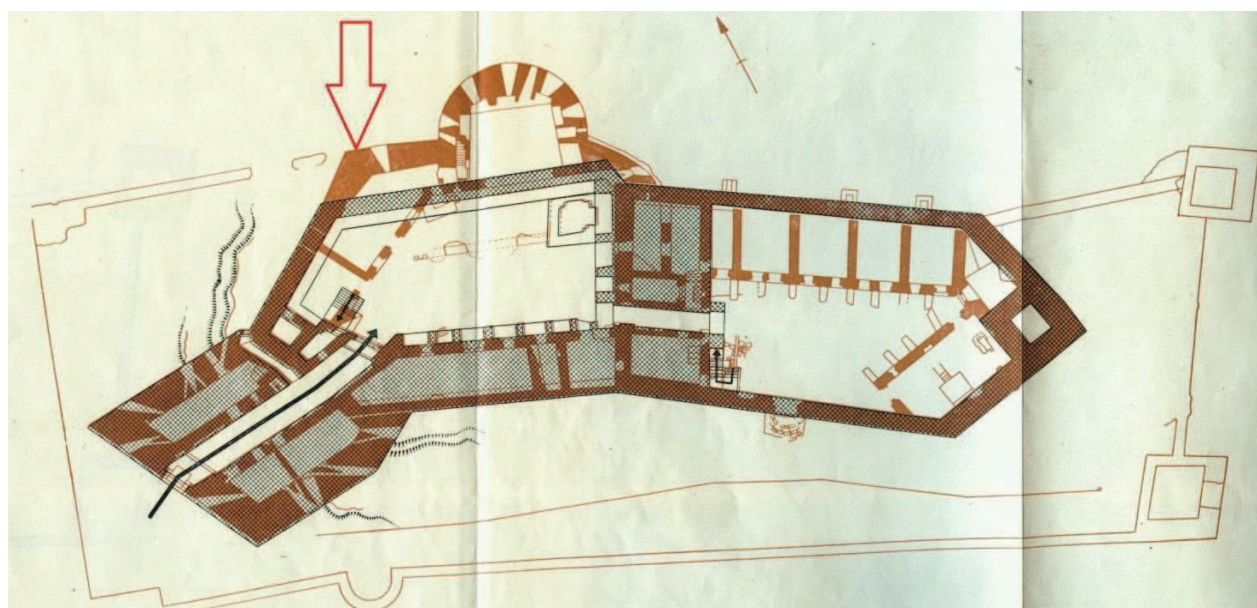
Unlike the Pomoryany castle, fragments of paintings are in the lower tier on the straight section of the northern defensive wall between the semicircular tower and the corner (Fig. 6).

**Fig. 10.** Location of the found fragment of polychrome painting at the plan of Yazlivets castle (the plan is taken from the publication of B. Gwerken (Queguin, 1960), p. 113])

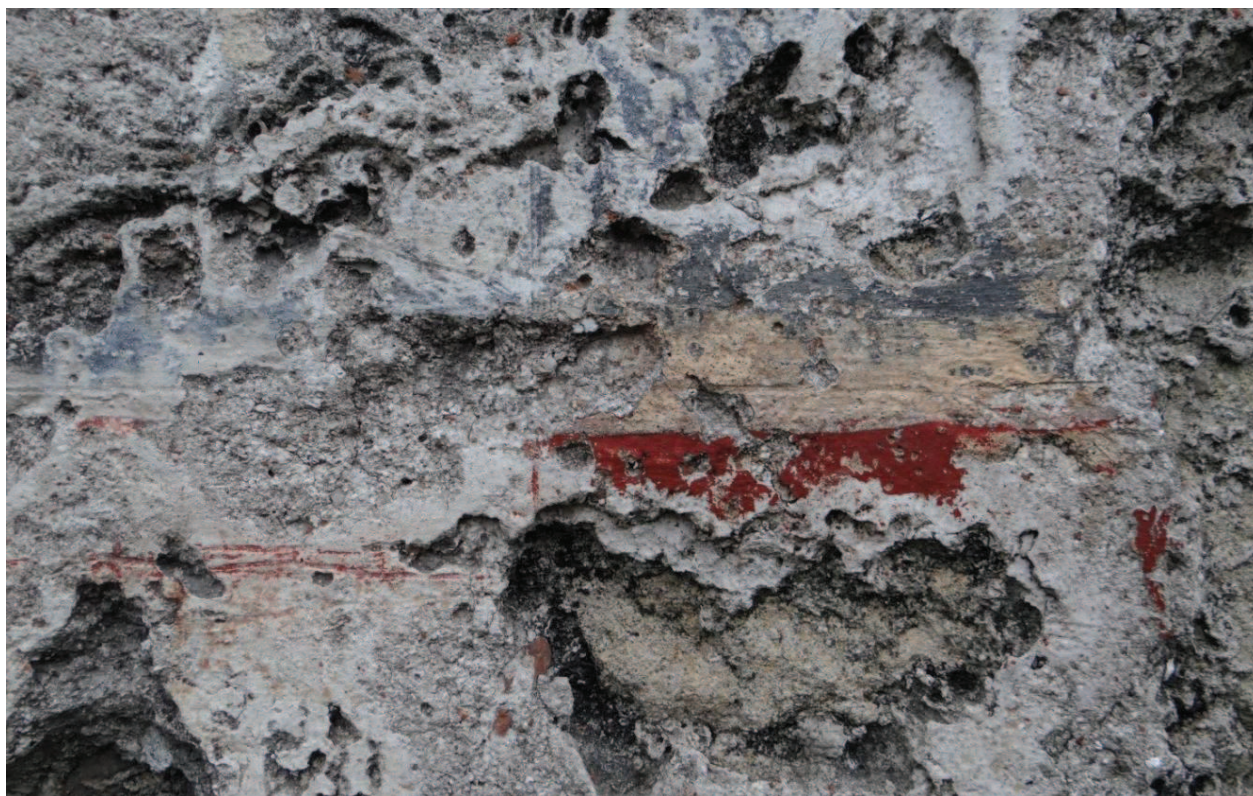
Unfortunately, only small fragments of polychrome survived, so it is unlikely to reconstruct the decoration. However, all fragments of the preserved plastering of the castle are worth examining in detail to determine the remains of polychrome. The preserved fragment shows a geometric pattern (Fig. 7) in several colours (red, grey, blue, white and ochre). It looks like it was an orthogonal grid of colourful lines that was combined with some other elements of the plant or figurative nature.

**Fig. 11.** *Fragments of paintings at the outer wall of the castle in Yazlivets.*

we date these paintings to the seventeenth century. The paintings found should be very carefully inventoried and examined, including laboratory tests. Small fragments of polychrome paintings on the two castles were fixed at the last moment. If no rescue work is carried out, these fragments will disappear in two to three years. Based on our discoveries, we can suggest that a similar way of decoration could be found at other Western Ukrainian castles.
