EVALUATION OF FIRE IMPACTED RAISED SLABS OF RESIDENTIAL BUILDING IN LVIV AND THEIR REINFORCEMENT

The research and analysis of technical conditions, deflections, and bearing capacity of subjected to fire impact reinforced concrete slabs of raised “panel per room” typical design model 1-480a of a five-storey residential building in Lviv are present.

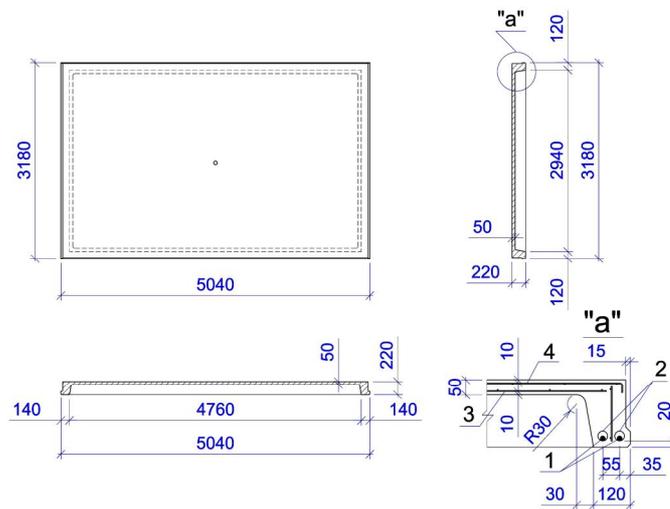
Fig. 2. Design features of the raised floor slab panel:
 1 – prestressed reinforcement; 2 – spiral ; 3, 4 – welded grids

The electromagnetic meter of the cover layer thickness IZS-10N was applied to determine the locations and parameters of the reinforcements. In addition, destructive sounding was also used in several separate places. The bottom tensioned zone of the flange of the raised floor plate is reinforced by welded mesh $\varnothing 3$ B-1, step 170 mm in two directions. The general principle of reinforcement is shown in fig. 2.
