¹Lucjan Gazda, ²Mykola Bevz

MATERIALS AND ARCHITECTURAL DETAILS FROM NATURAL AND ARTIFICIAL STONE OF KING DANIEL ROMANOVICH'S 13th CENTURY RESIDENCE IN CHOLM

Abstract: *Materials obtained during archaeological excavations on the place of castle in the city of Cholm (today Chełm in Poland), in the area of king Daniel's 13th century residential complex, have been subject to examination. They are in the forms of bricks and glazed tiles, as well as sizeable shapeless and purposeless accumulations indicating post-manufacturing remains. The materials are white, green and multi-colored. They refer to Halychian alabasters and green glaukonitite from Cholm, which were originally used there. The examination of white materials was performed. The conducted examination indicated that the materials in question were manufactured using other than ceramic technologies, but similar to the ones used to produce silicate materials nowadays. As raw materials, chalk and biogenic silica obtained from a horsetail were used. The petrification procedure was conducted in hydrothermal conditions. As a result a material structurally similar to marble was obtained.*

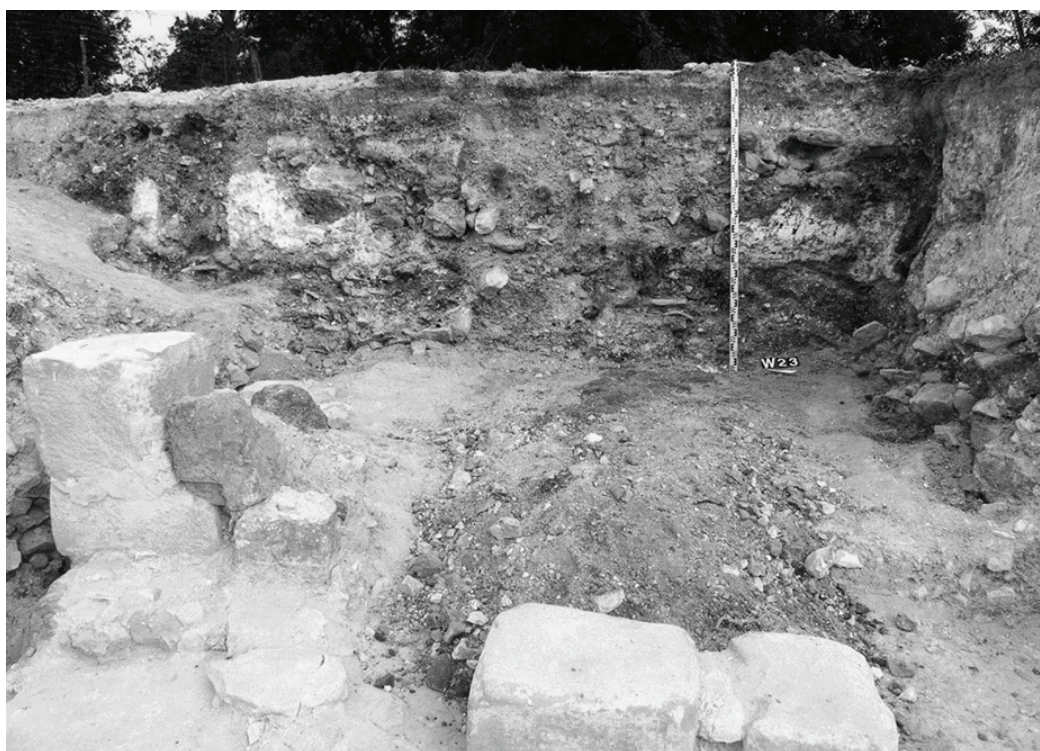
Fig. 2. Eastern wall of trench no. 23 within the residential and sacral complex at Wysoka Gorka in Cholm (photo S. Golub). Retort synthesis of limestone from chalk (left) and chalk raw material (right).

The materials obtained from the eastern profile of excavation no. 23 were subjected to analysis, where the object of distinctly outlined rectangular shape and vague purpose was initially documented (Fig. 2, from the left), which is accompanied by intentional accumulation of chalk (Fig 2., from the right). This object is located beyond residential arrangements at the east bank. Archeologically, they can be dated for the 2nd or 3rd functioning phase of Daniel’s residential and sacral complex, after the destruction of outer walls and raising the ground level, so after the fire from 1256.

The samples from the object, which were operationally called as retort (Fig. 2, from the left), were taken to the research. At the upper part of the object, there is little modified white and grey chalk (Fig. 3a), below light white and grey raw material, harder and more compact than chalk, with distinct replicas of plants stems of segment structure and longitudinal ribs. These replicas have the form of longitudinal negatives as well as longitudinal and transversal cross-sections of stems and leaves of plants morphologically corresponding to a horsetail (*Equisetum* L.) (Fig. 3b). The organic substance has not been preserved. Inner and bottom parts of retort are filled with hard, structurally homogeneous (microcrystal) light grey and white material, cracked of distinct shell and an irregular sharp-edged burring fracture (Fig. 3c).

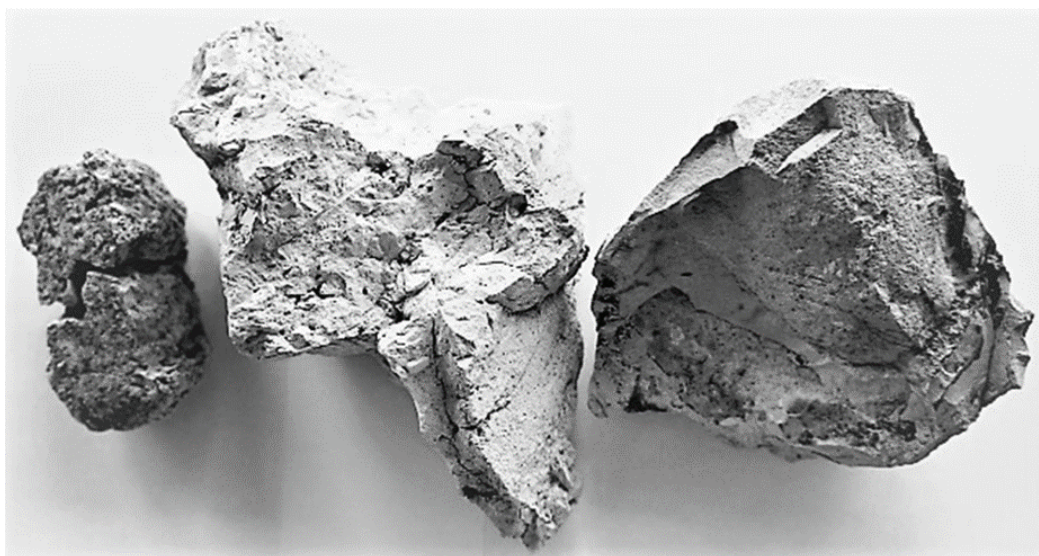
Fig. 3. Sequence of materials and materials from the retort: writing chalk, partially modified chalk with horseshoe replicas (b), microcrystalline carbonate (c).

The materials taken from retort underwent the research: writing chalk, partially modified chalk with replicas of horsetail as well as microcrystal carbonate material (Fig. 3). Phase studies were performed with the use of polarizing optical microscope, electron microscope SEM and X-ray diffraction. The chemical analysis in the micro area with the use of electron microscope SEM with EDS module was also carried out.

The material, in the middle part of retort (Fig. 3 b), is in light grey and white, harder and more bound than the chalk as well as it is not susceptible to plasticity after adding water. There are a lot of stem replicas of plants with segmental structure and longitudinal ribs. In the view of scanning microscope, the structure of horsetail surface is clearly legible (Fig. 6).

The material from the bottom part of retort (Fig. 3c) is macroscopically light yellow and white without distinct structural and textural principles. It is cracked along with the shell surface of unbundling. The material is hard, while stroking it makes soundless noise, In addition, it is fully durable in water.

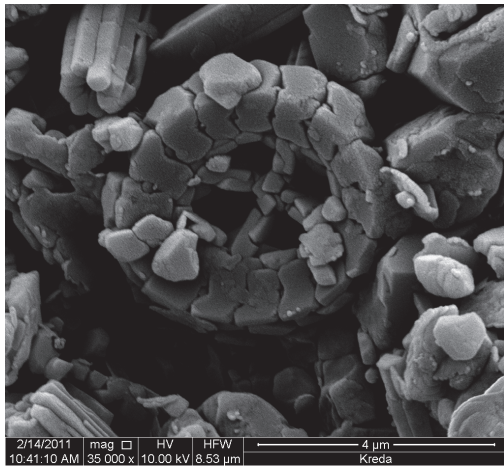
Fig. 5. Biomorphic structure of Cholm chalk writing in the image of scanning microscope

Cholm writing chalk is a typical loose biocalcarenite of dominating hole saw bioclasts in its structure (Fig. 5). In mineral terms, it is a pellicle calcite (above 95% of CaCO₃) with an insubstantial admixture of loamy minerals, quartz and iron sulphides. It is a soft rock, subject to liquification after adding water and prone to be molded in the plastic state.
